R and **CENTER**
LABORATORY
TECHNICAL REPORT

NO. 12570

FAILURE ANALYSIS STUDIES OF T-142 TRACK PADS

JUN 1981

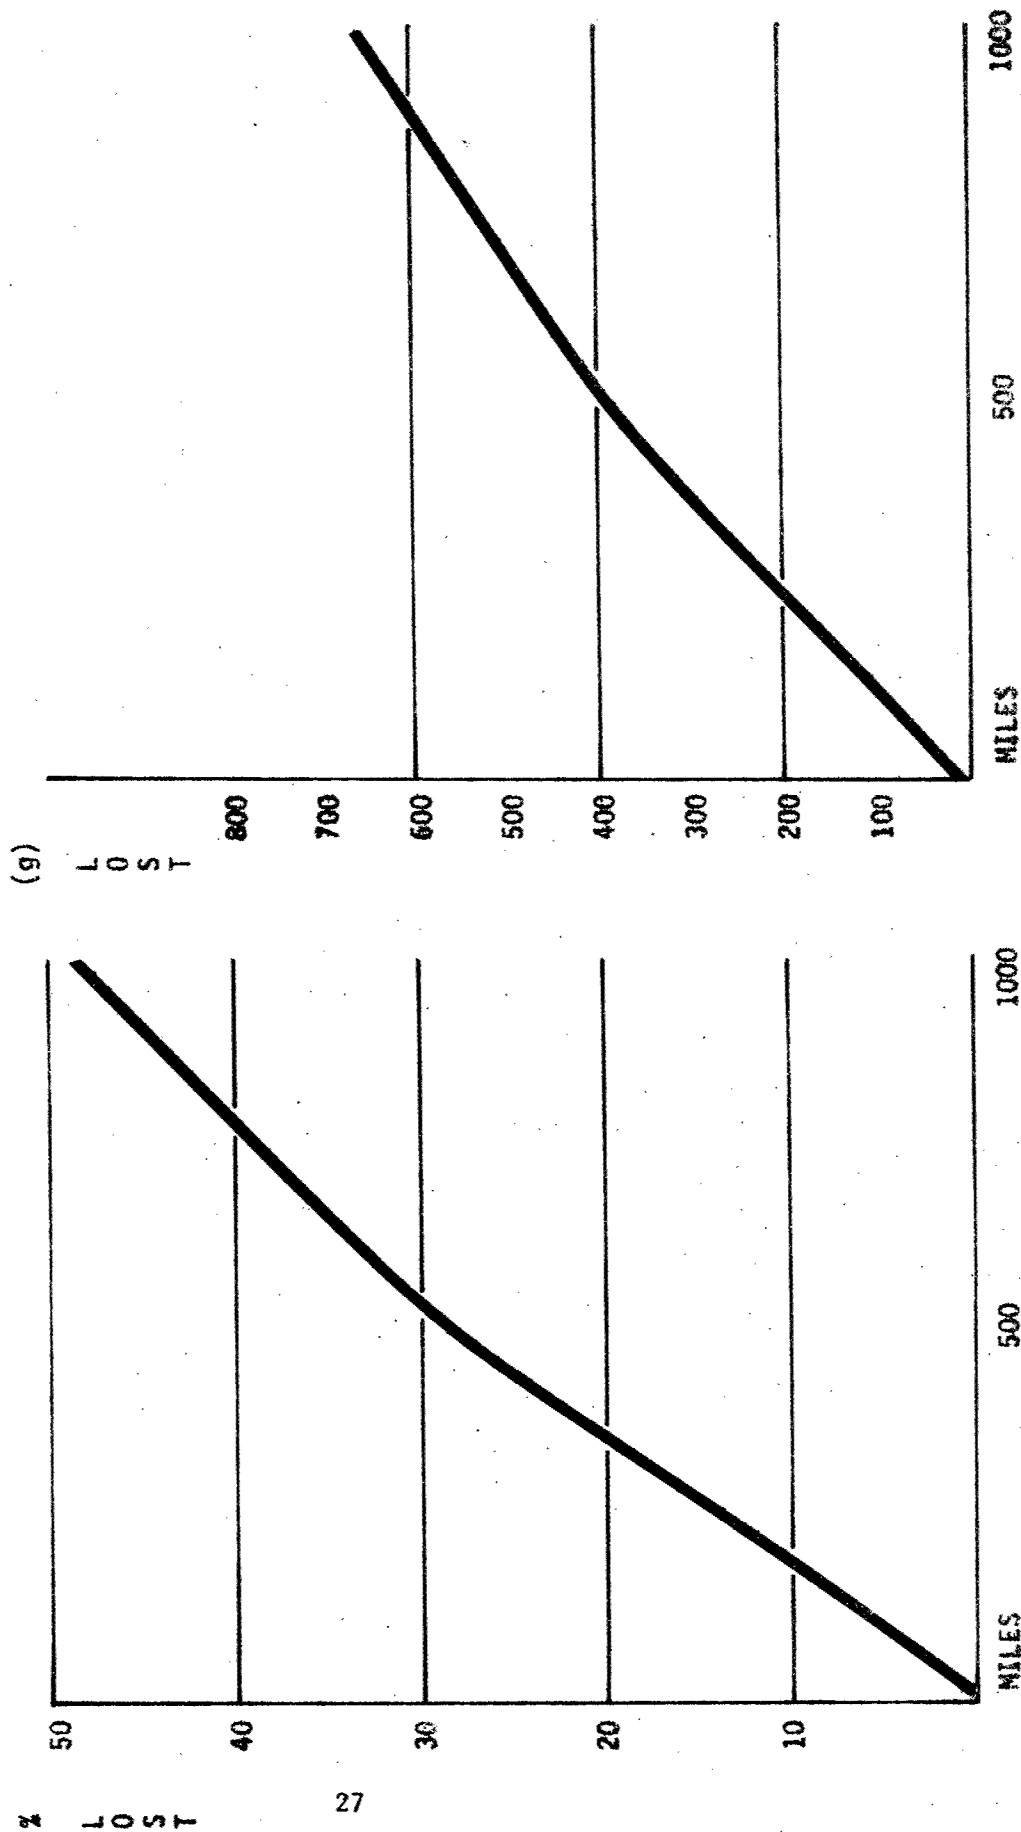
SET NUMBER 6

YUMA GRAVEL

1. Table #1 gives the comparative rating of all the sets for the three phases of the test.
2. Graphs #1-8 show each set individually graphed as to performance on the 2,000 mile paved road test. These graphs show the loss in grams from the pads and the percent loss at each weighing interval.
3. Graphs #9-16 show each set individually graphed as to performance on the 1,000 mile gravel road test. The weights and percents graphed represent the same type of information as those graphed on 1-8.
4. Graphs #17-25 show each set individually graphed as to performance on the 500 mile hilly cross-country test. These graphs show the same type of grams and percent information as the previous two categories.
5. Graphs #26-28 show the comparisons of each set of pads for the three phases. These graphs give a direct comparison of the percent of rubber lost by each set during each phase.

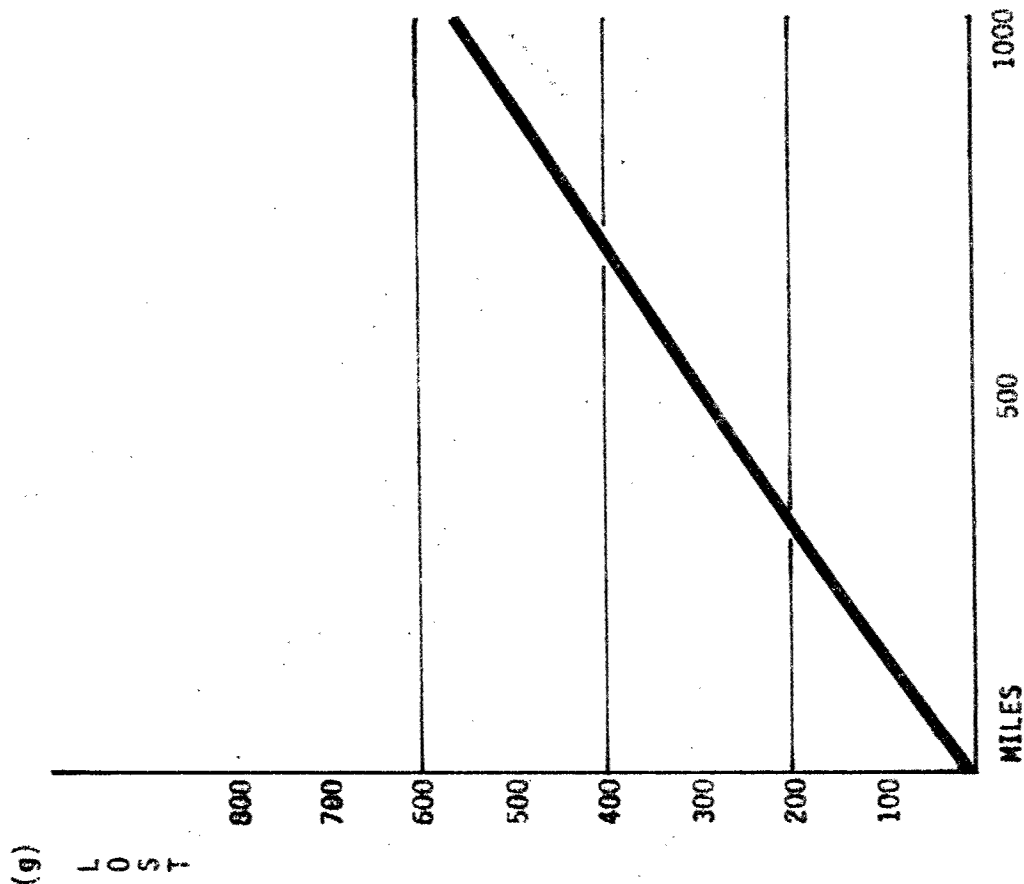
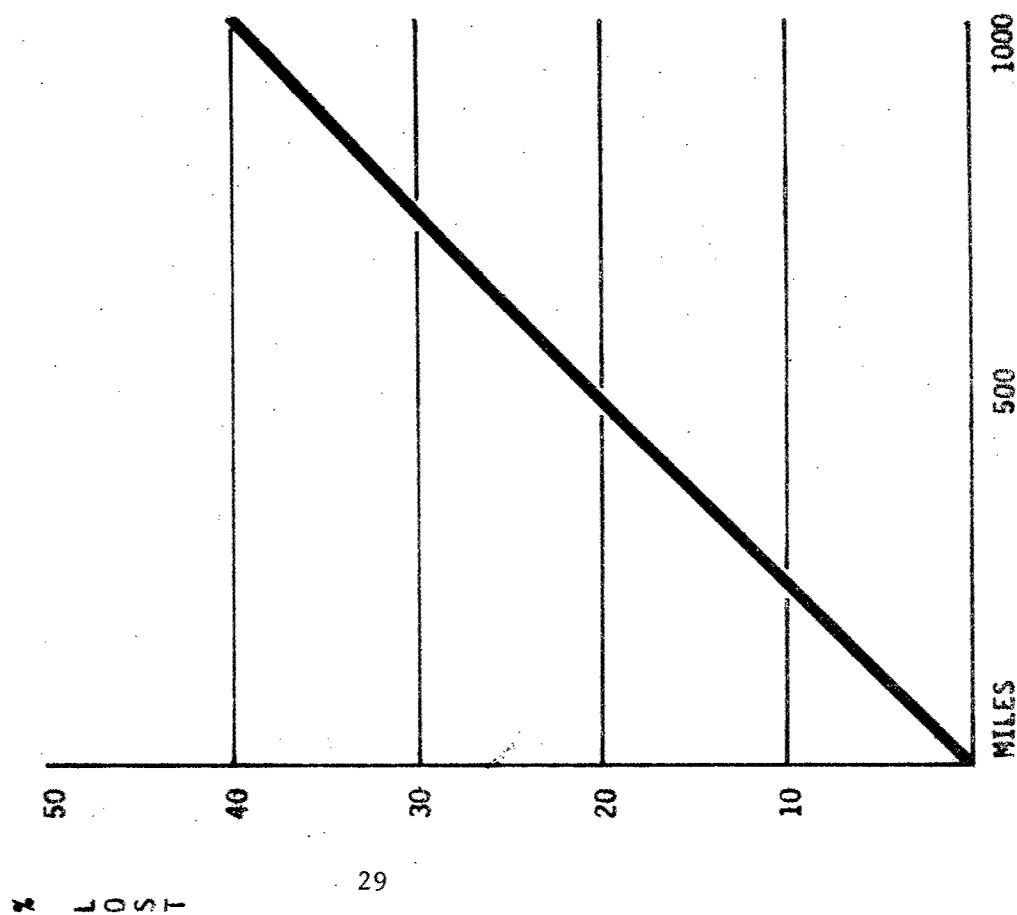
SET NUMBER 0

YUMA GRAVEL

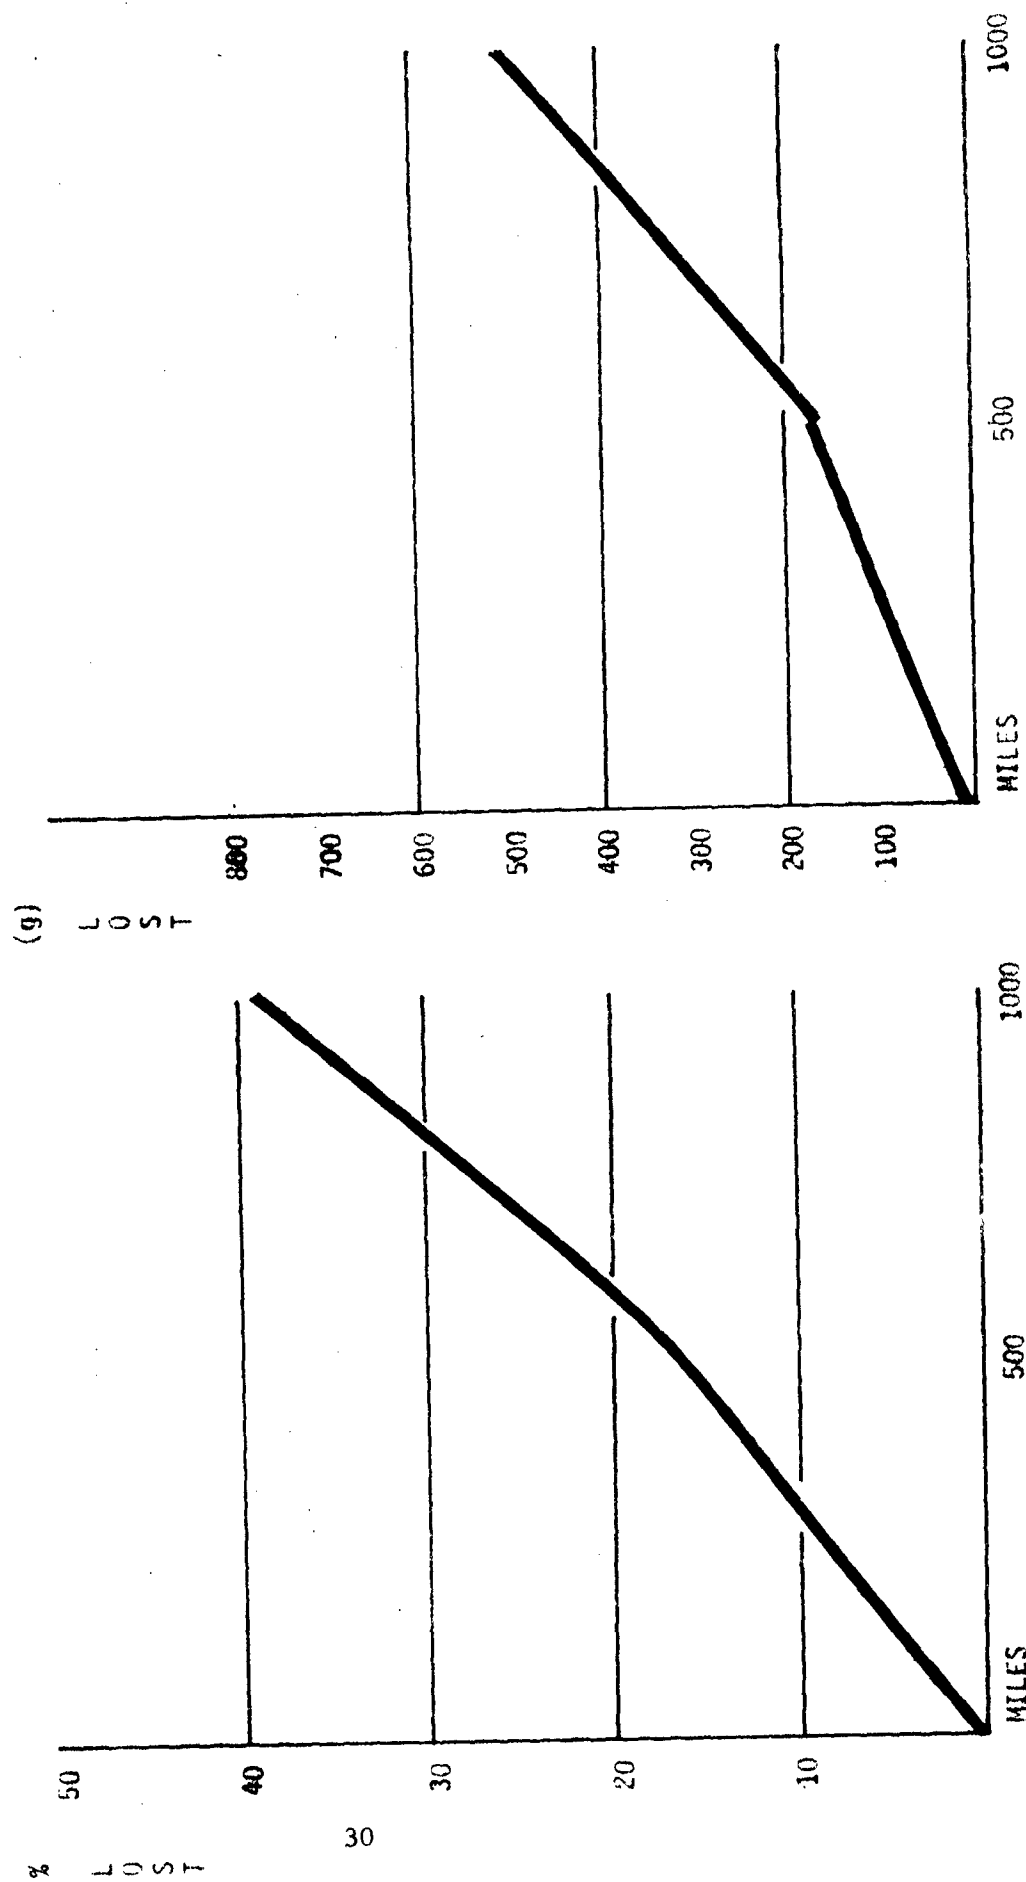
SET NUMBER 9

YUMA GRAVEL

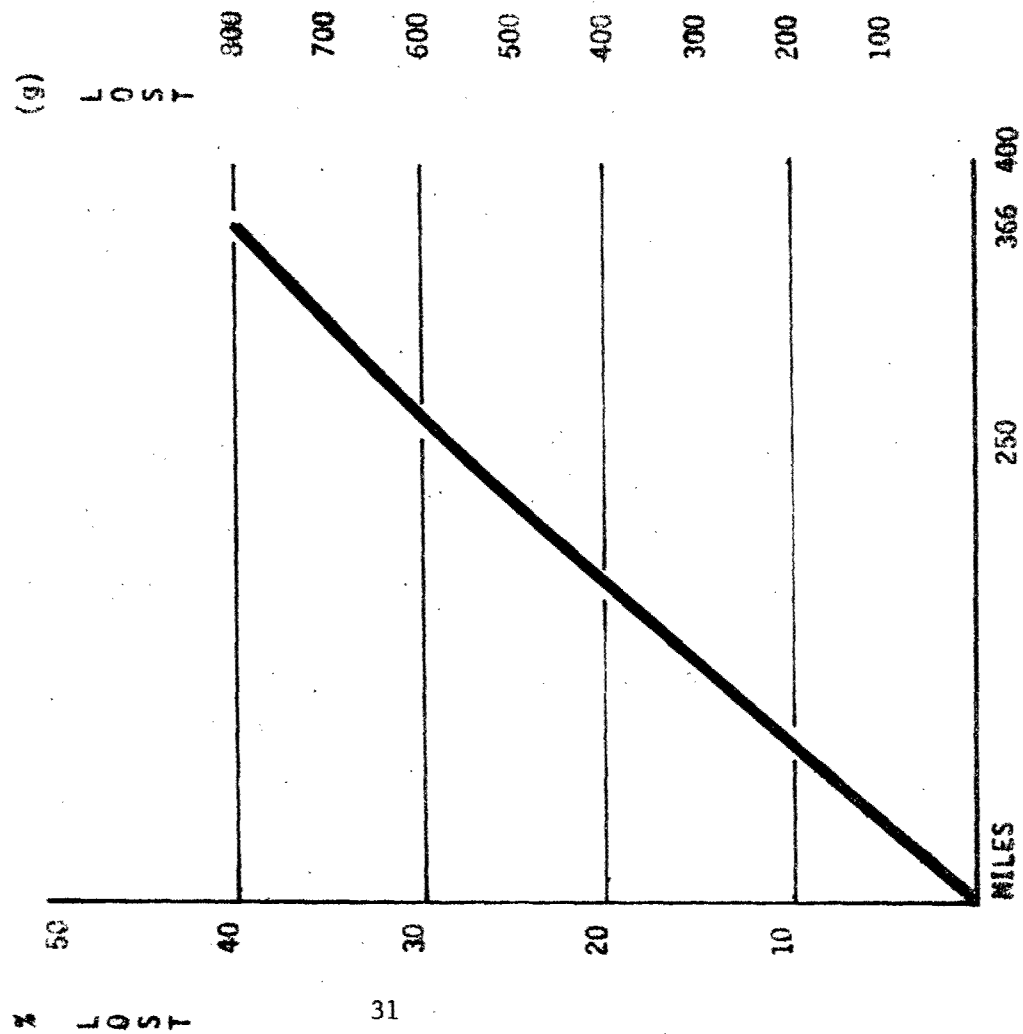
SET NUMBER 1

YUMA CROSS COUNTRY

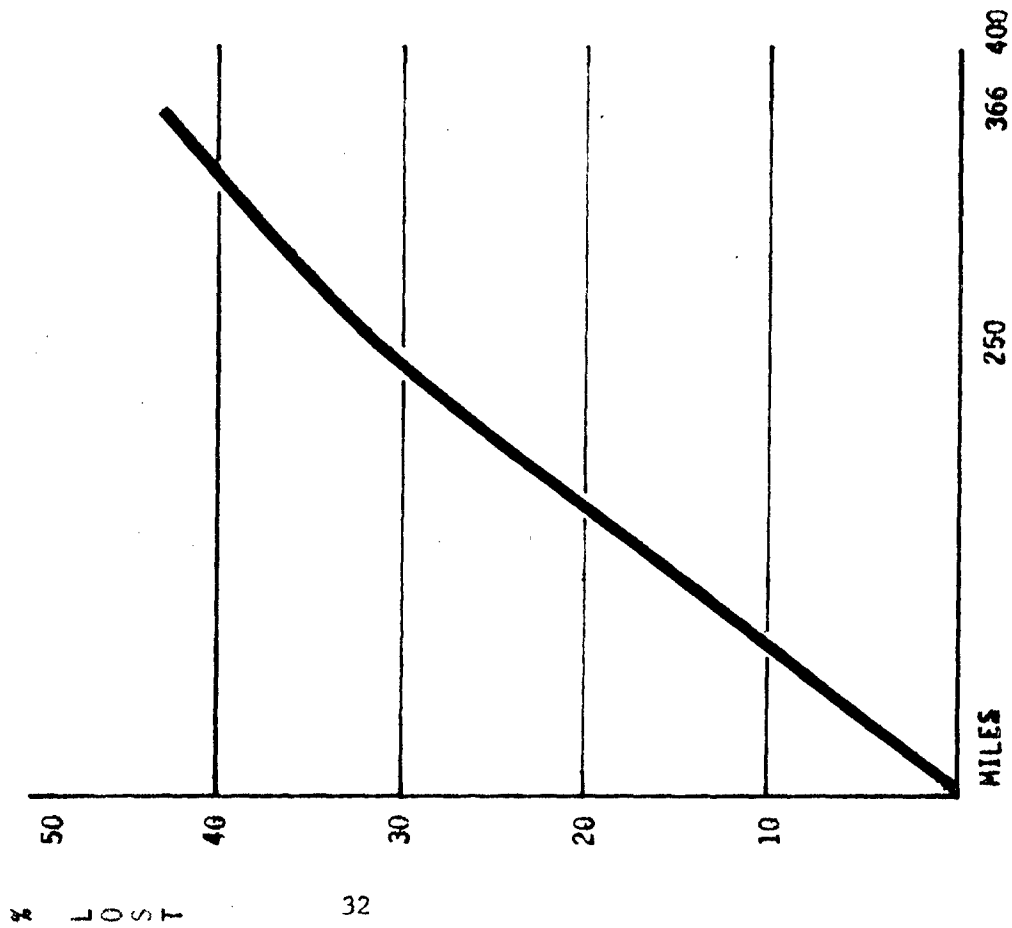
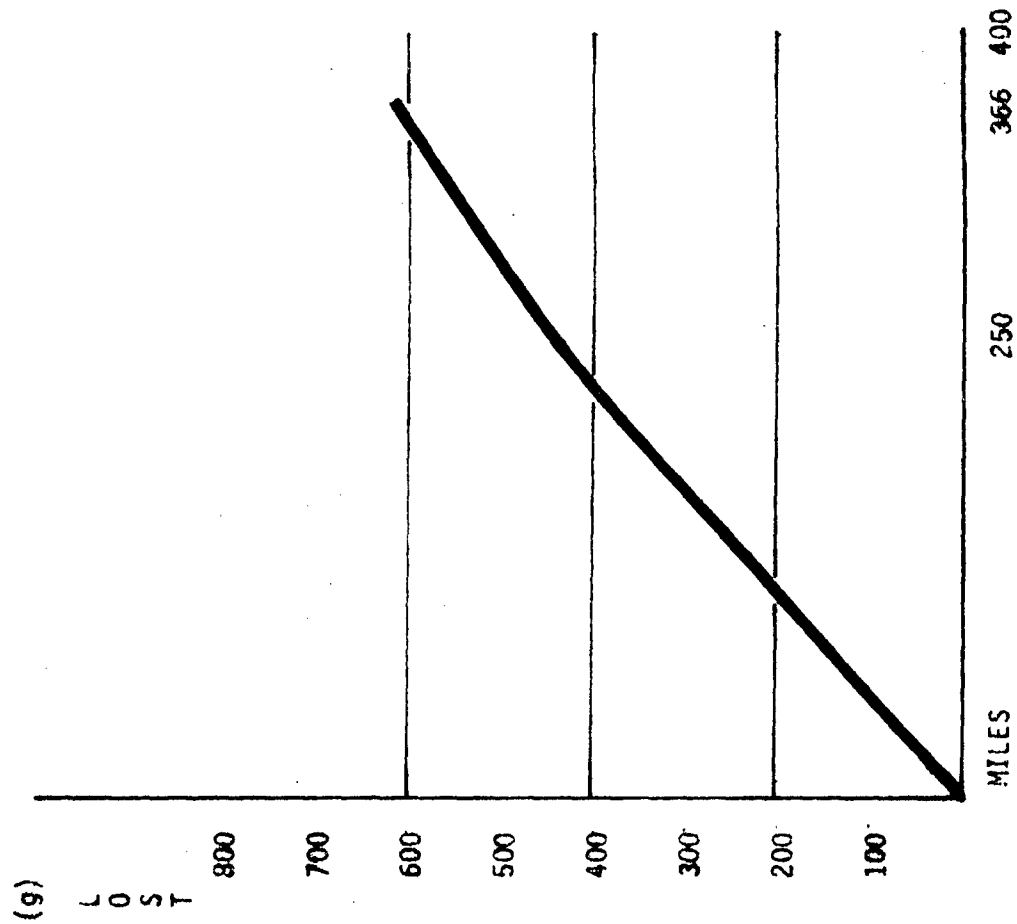
SET NUMBER 2

YUMA CROSS COUNTRY

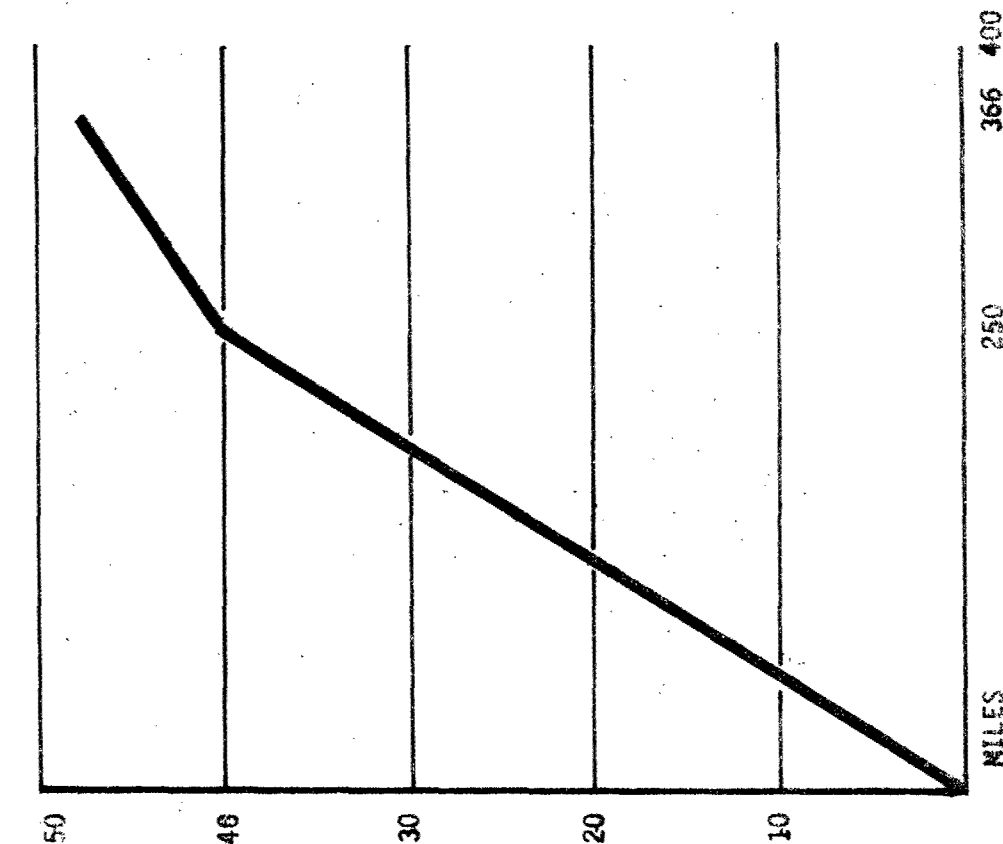
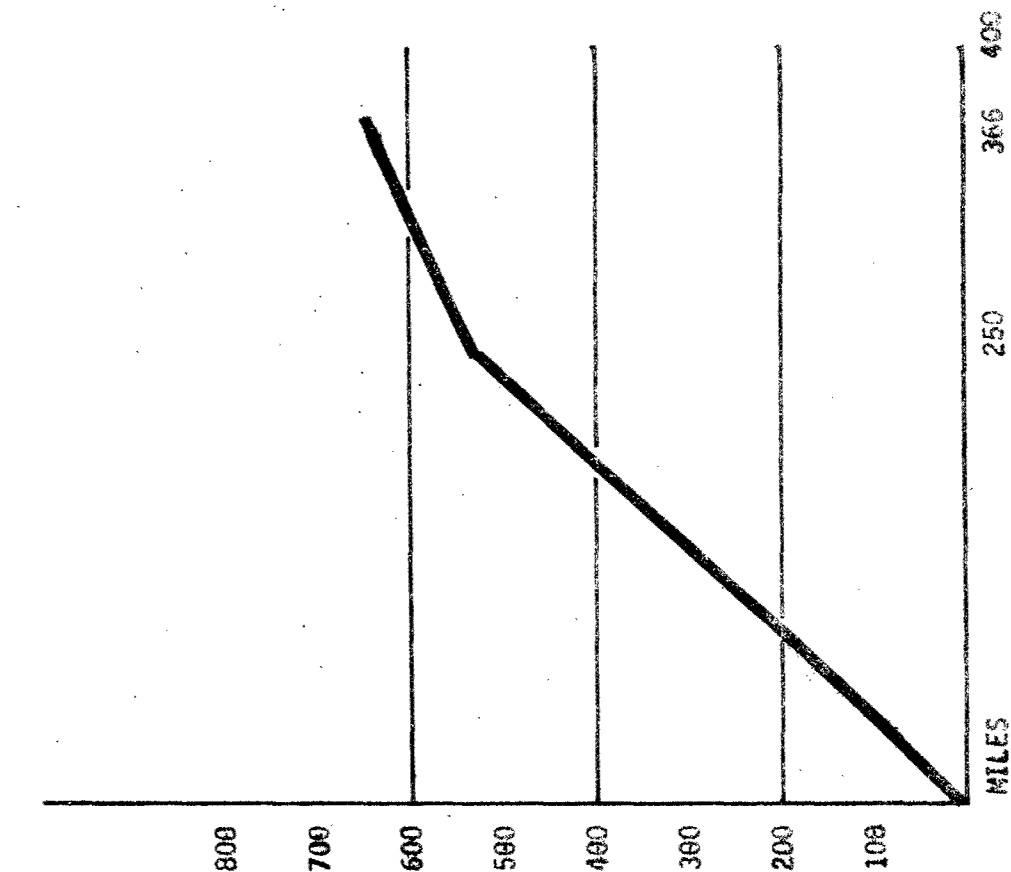
SET NUMBER 3

YUPA CROSS COUNTRY

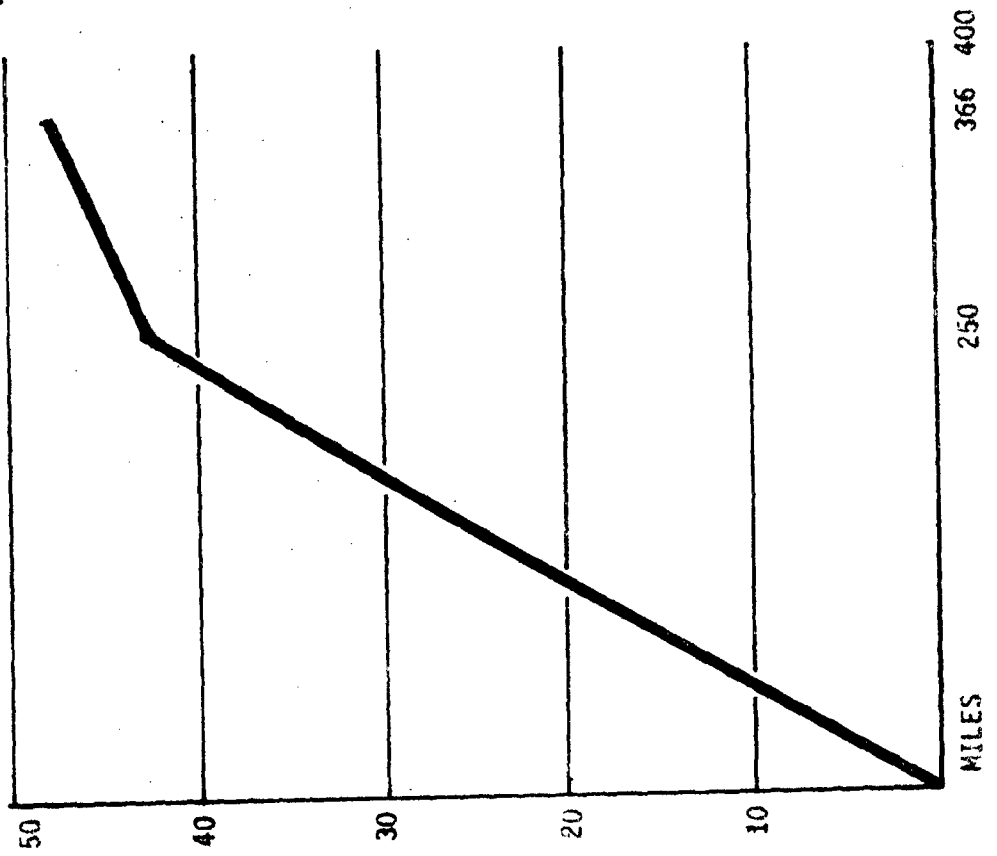
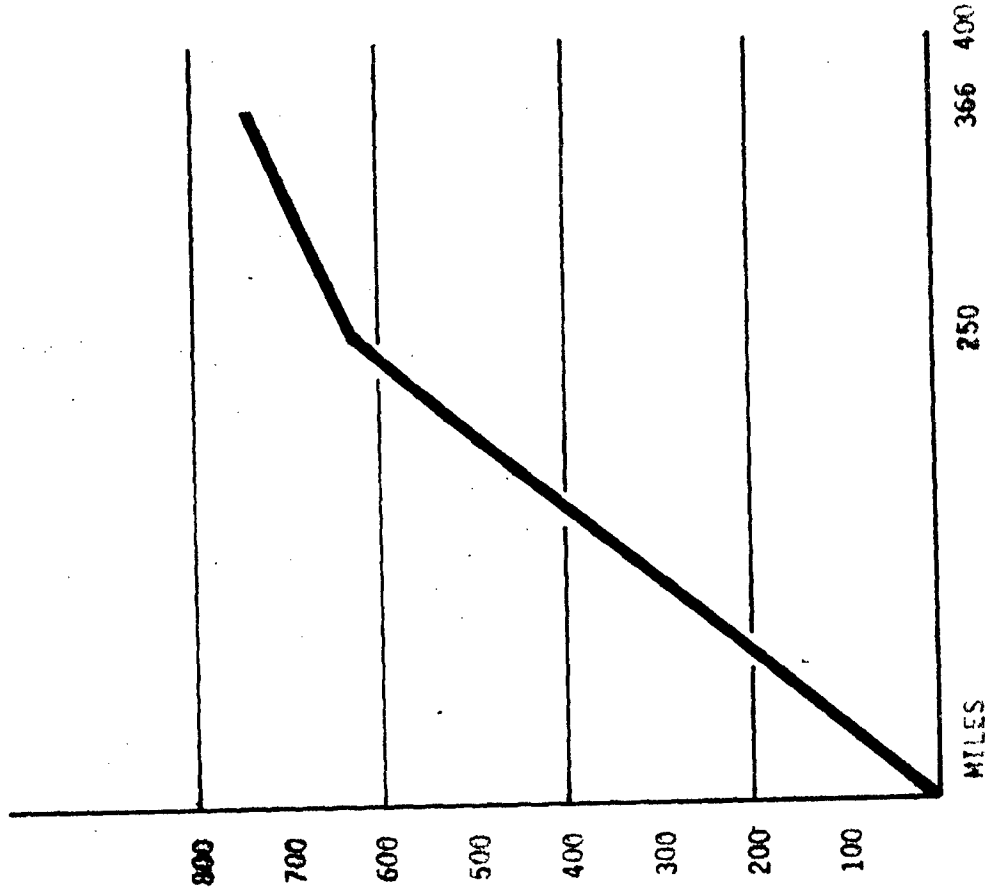
SET NUMBER 4

YUMA CROSS COUNTRY

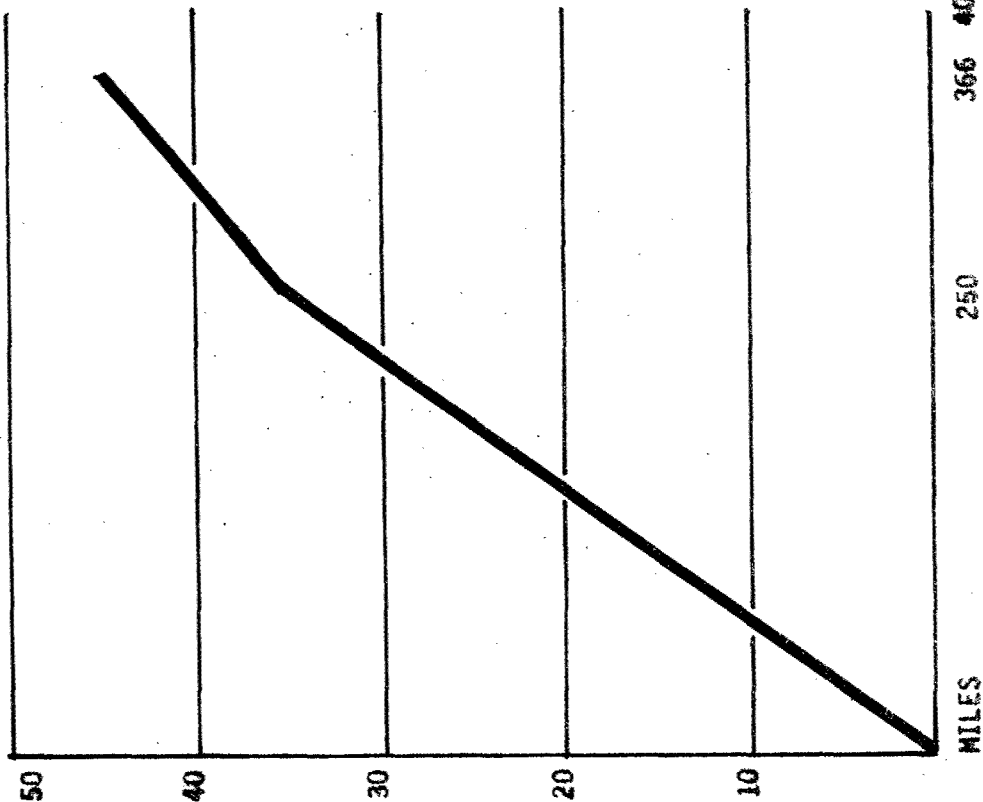
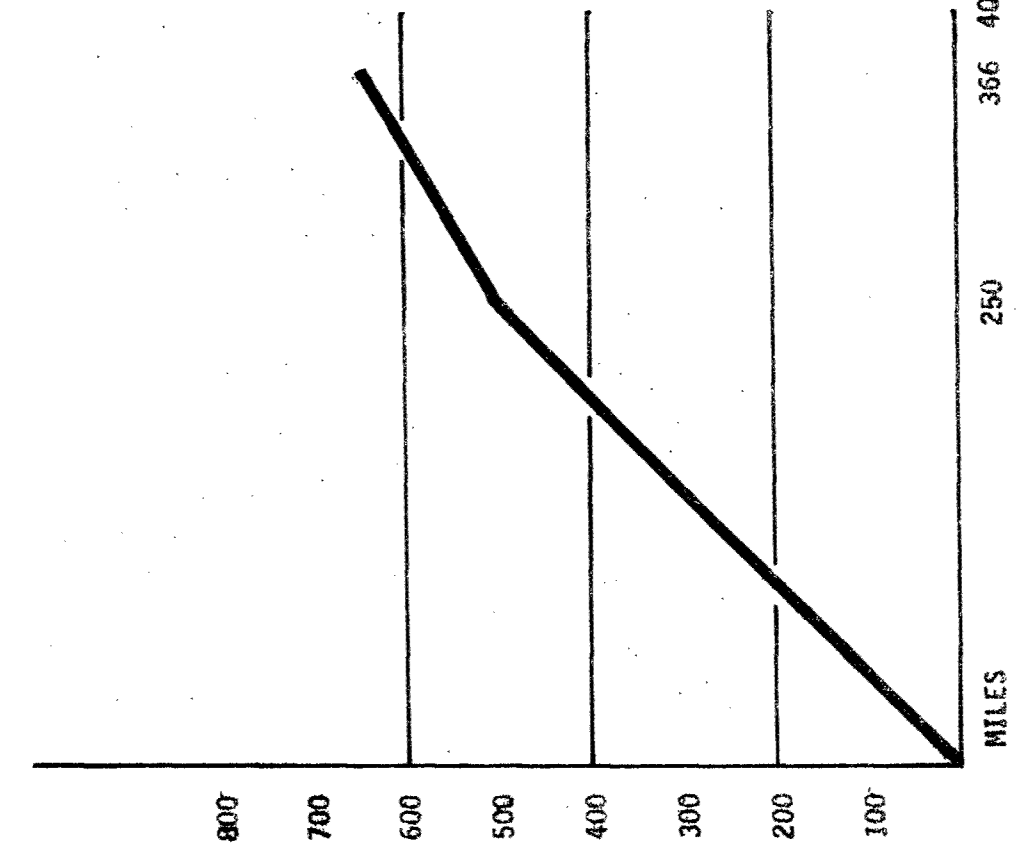
SET NUMBER 5

YUMA CROSS COUNTRY

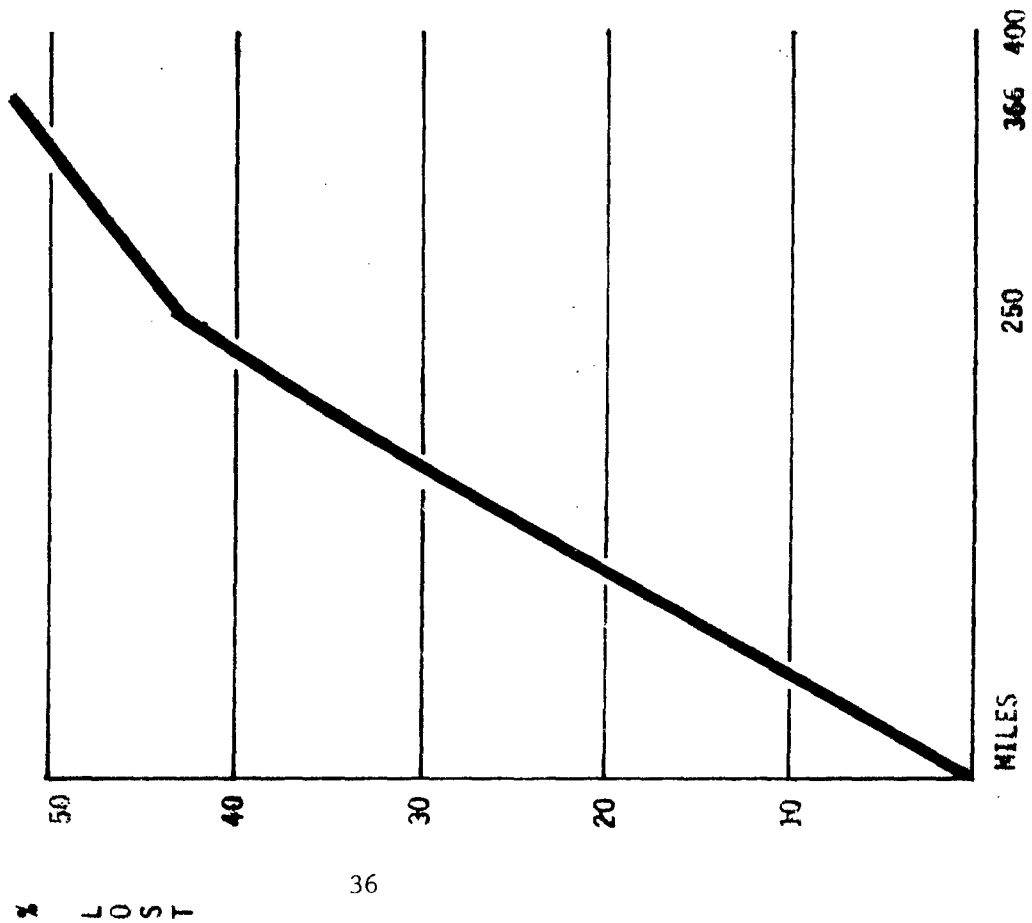
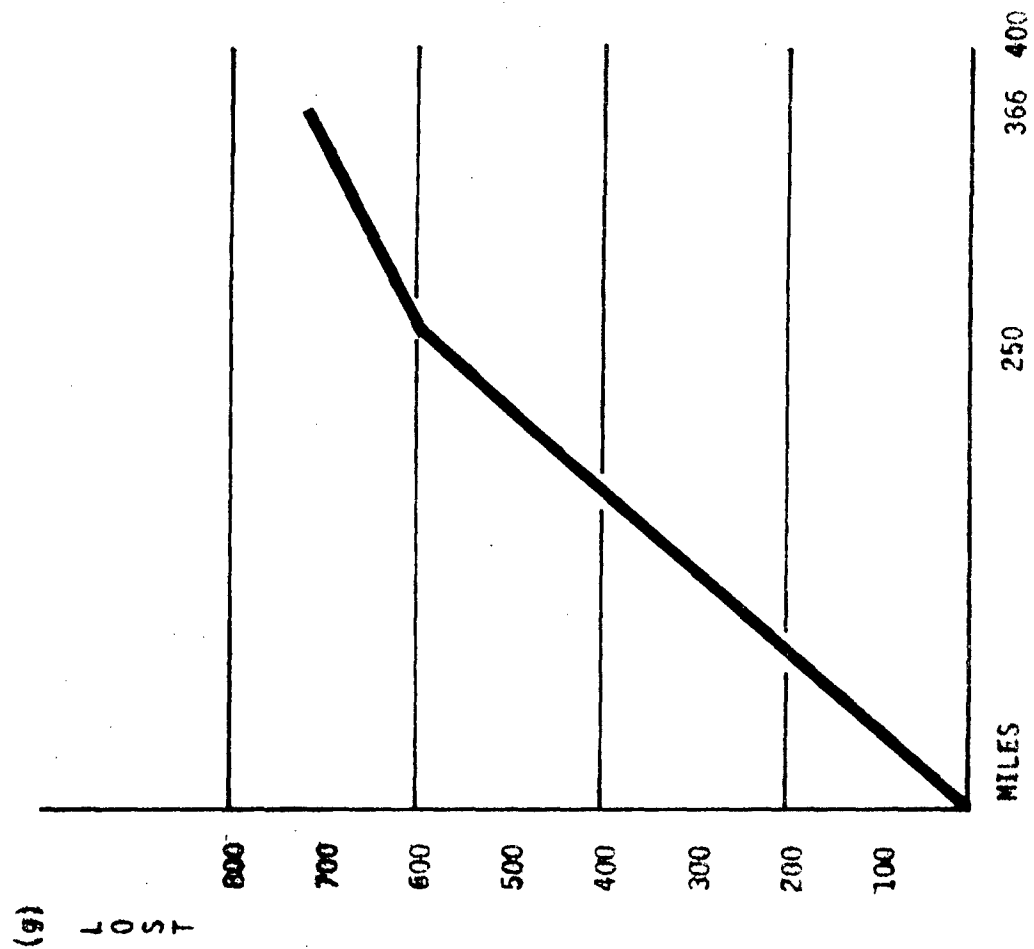
SET NUMBER 6

YUMA CROSS COUNTRY

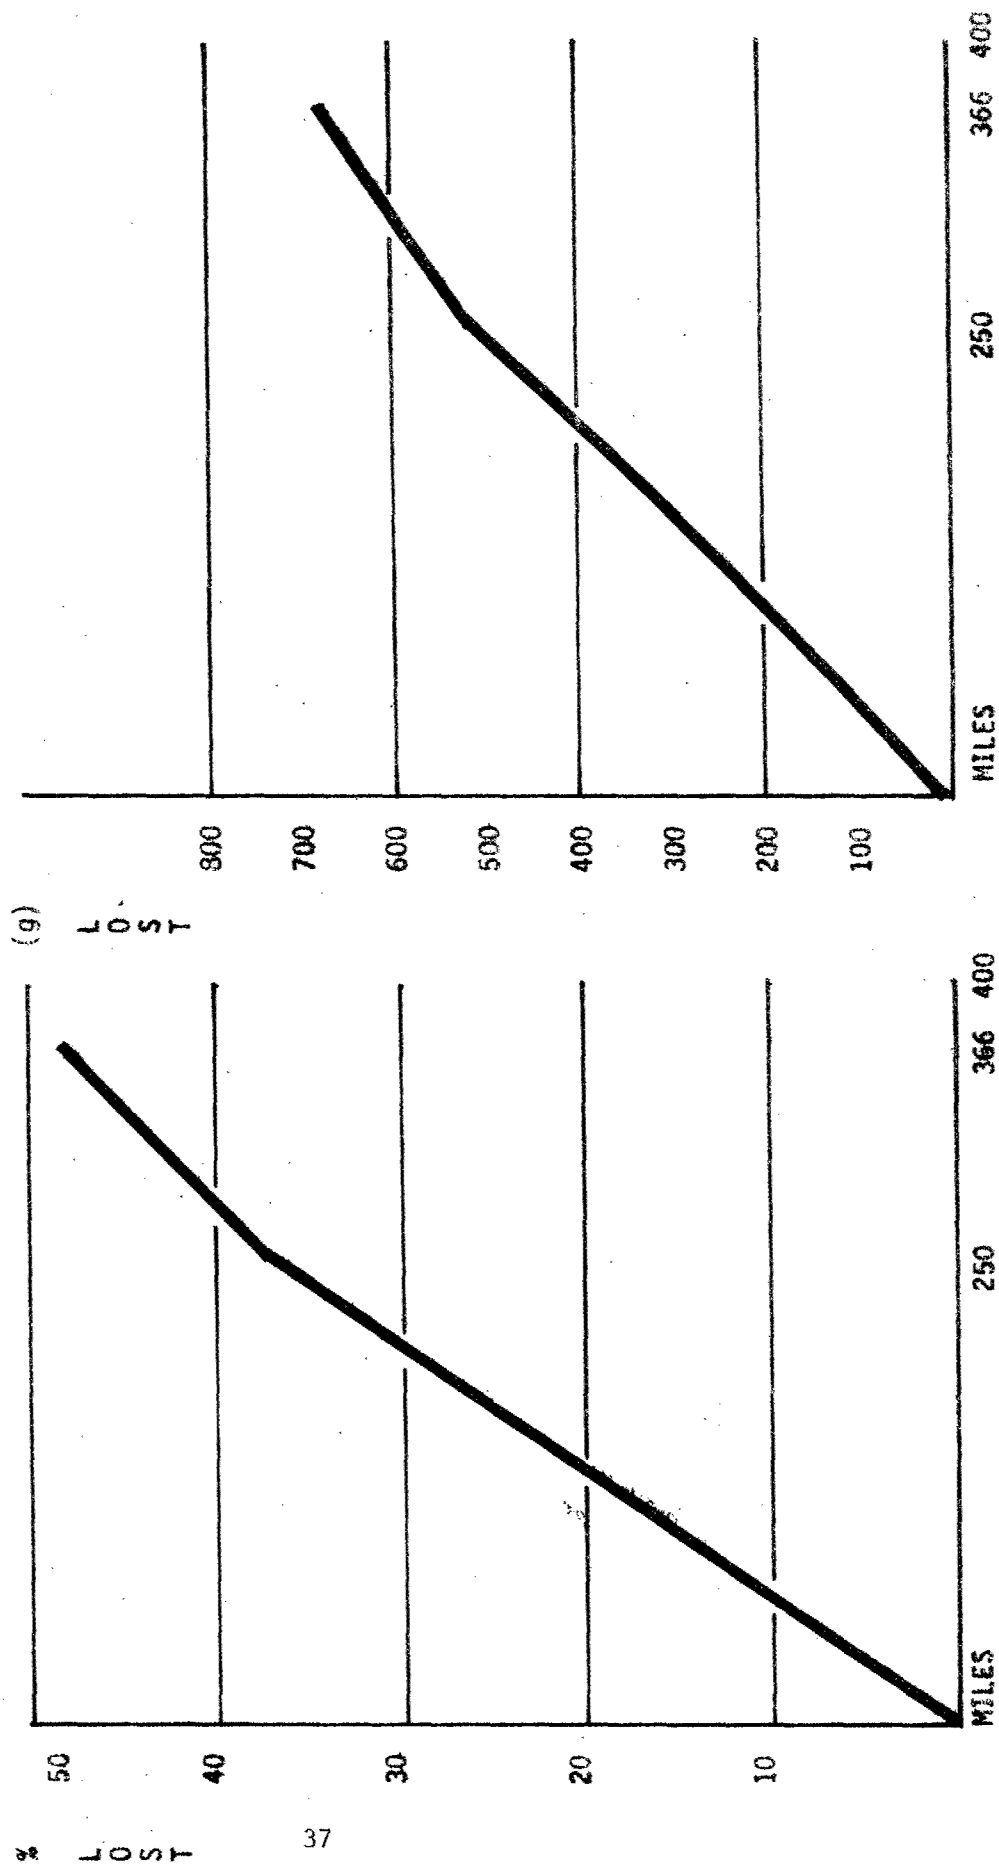
SET NUMBER 7

YUMA CROSS COUNTRY

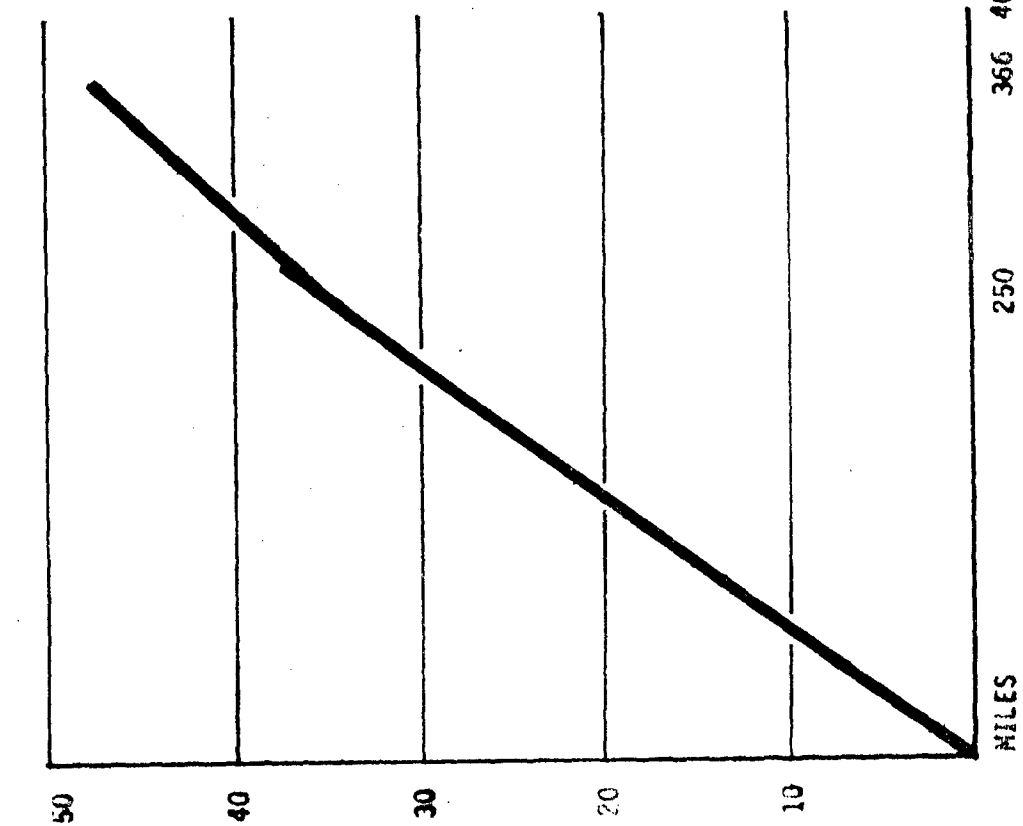
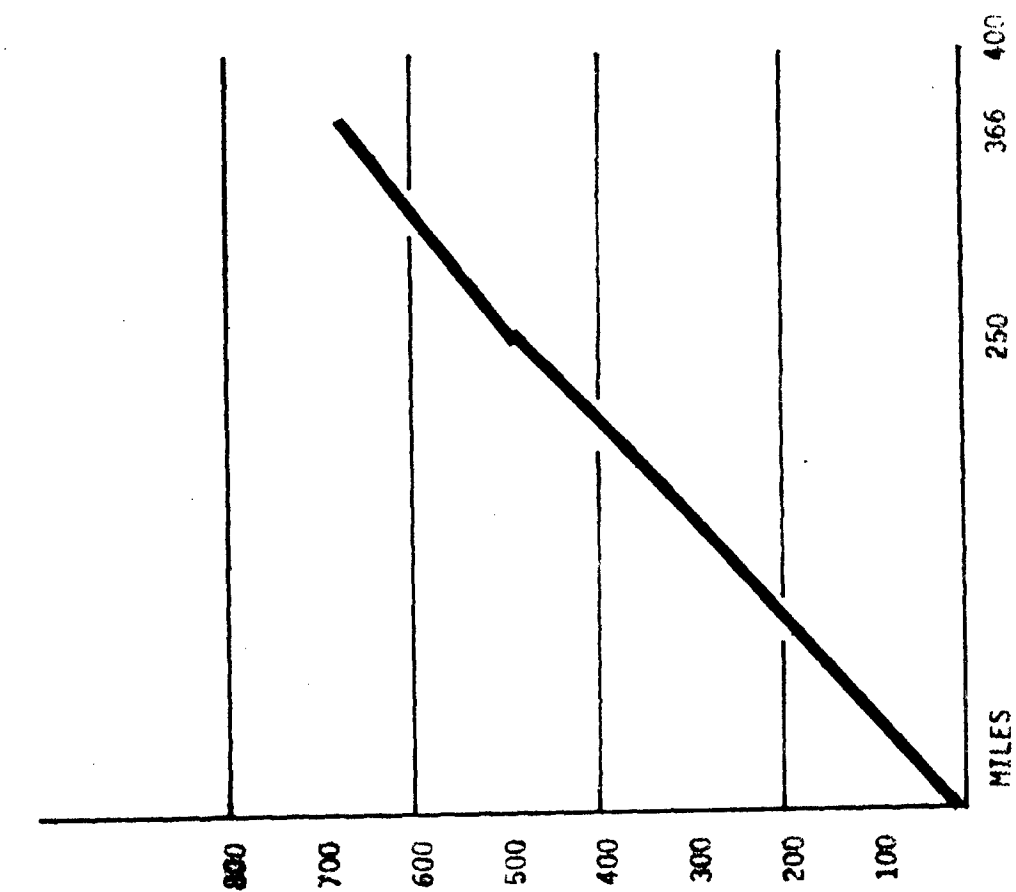
SET NUMBER 8

YUMA CROSS COUNTRY

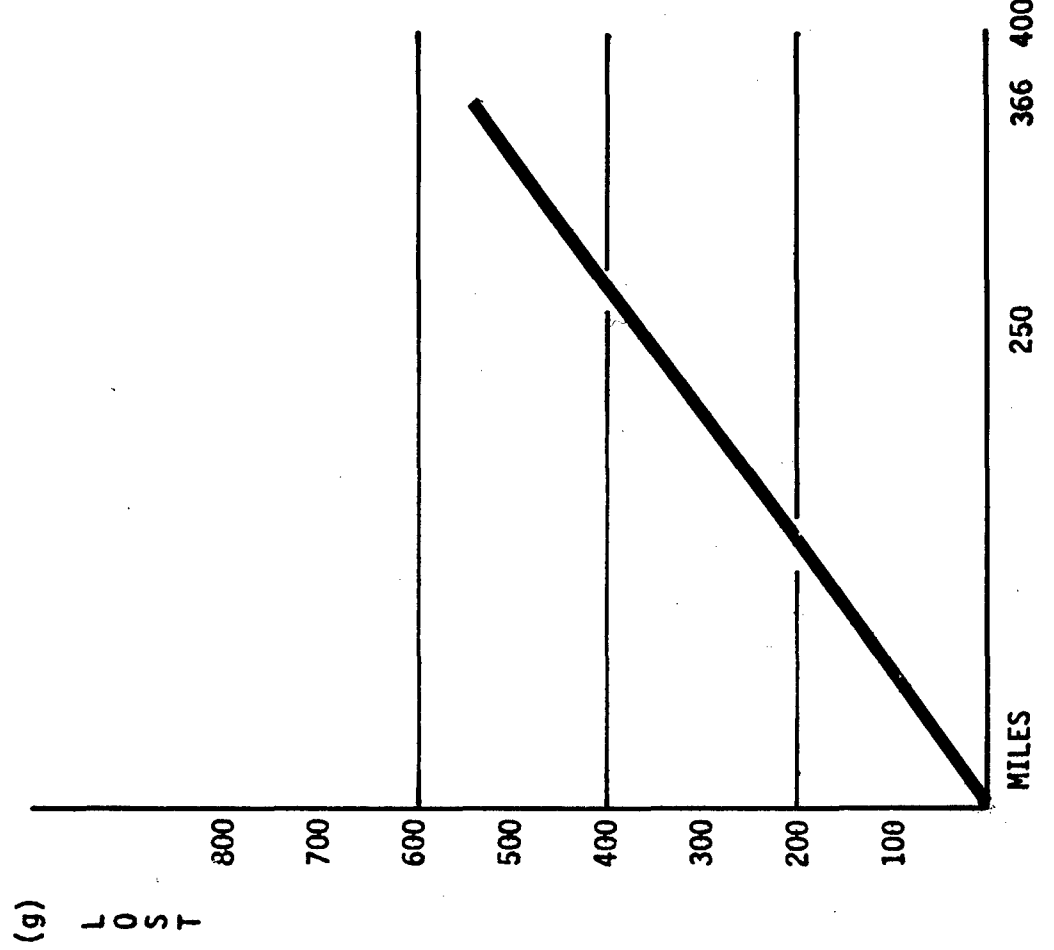
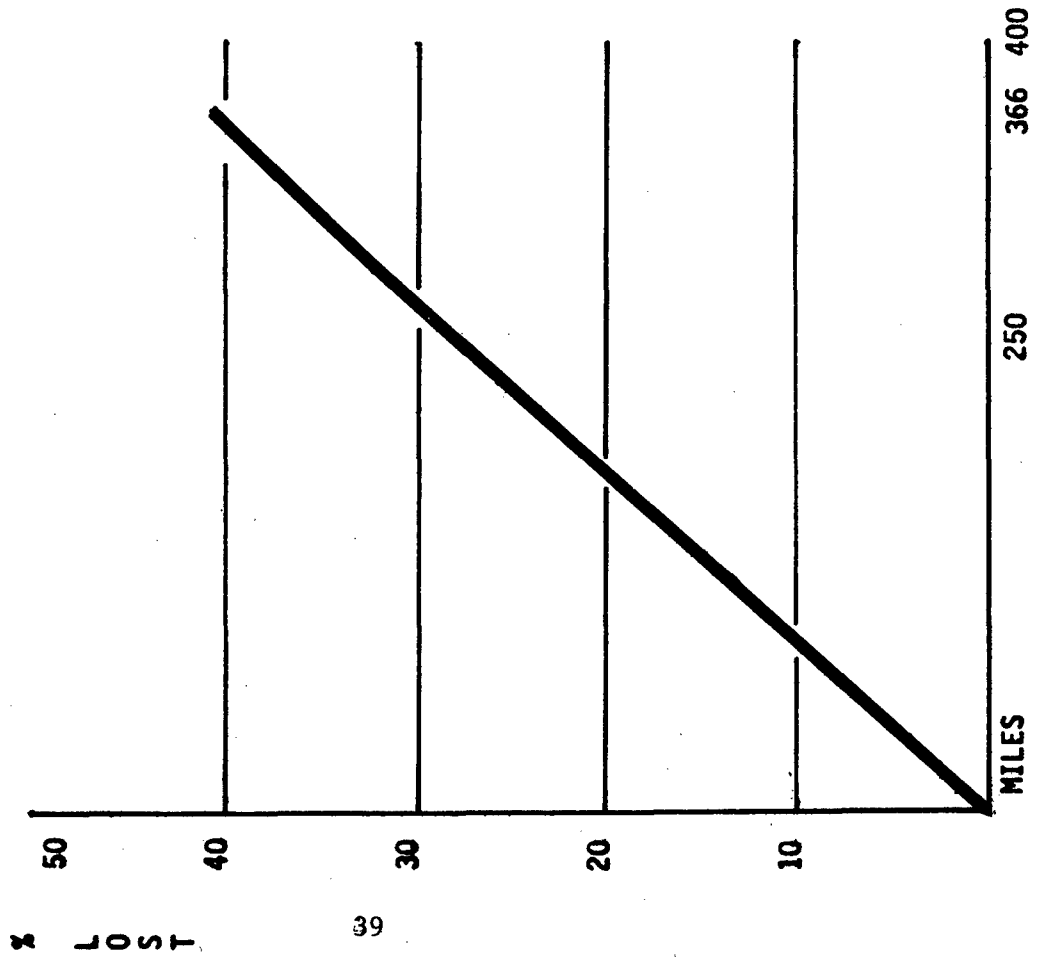
SET NUMBER 9

YUMA CROSS COUNTRY

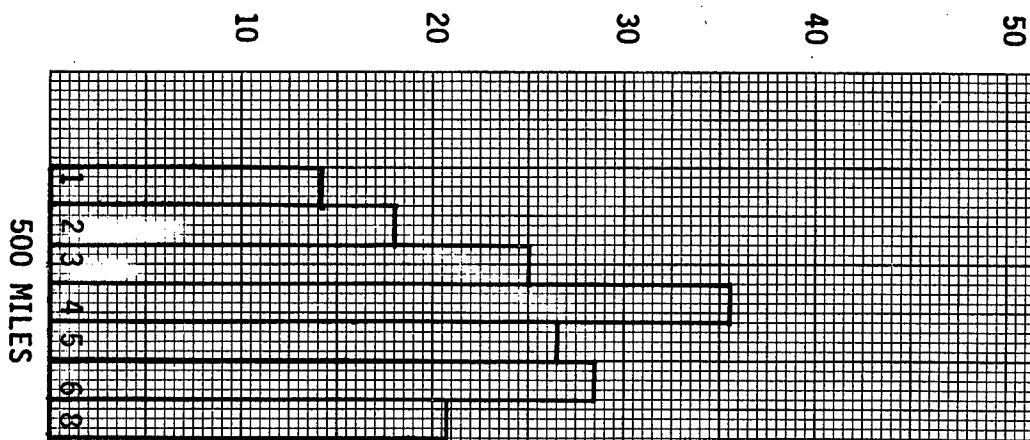
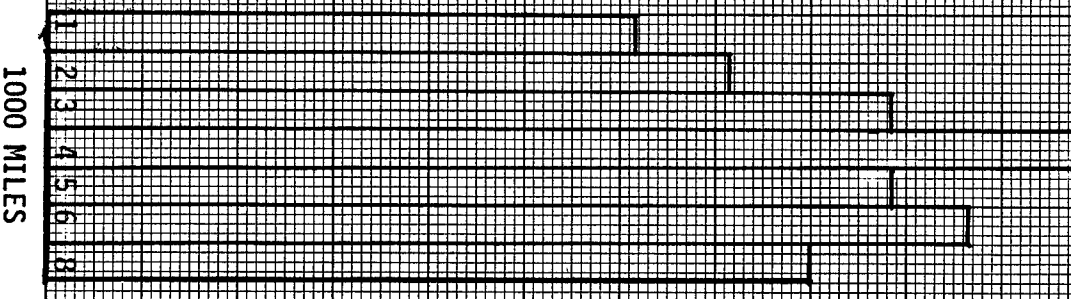
YUMA GRAVEL TEST

% LOSS
